## Facilities Planning Assessment

KINGSBURG JOINT UNION HIGH SCHOOL DISTRICT 2019

The District has recognized a need to develop a facilities improvement program to repair and modernize its school facilities and infrastructure. In January 2019, the District retained SchoolWorks, Inc. to evaluate the Kingsburg High School site.

The Facilities Planning Assessment (FPA) identifies and evaluates the current conditions of the District's school facilities, providing an estimated cost summary for modernization, repairs and upgrades, infrastructure and site work, portable building replacement and future new construction projects.

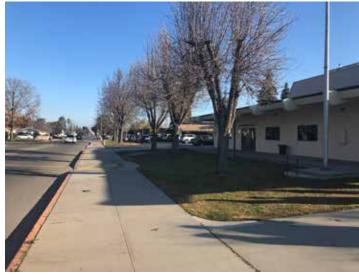
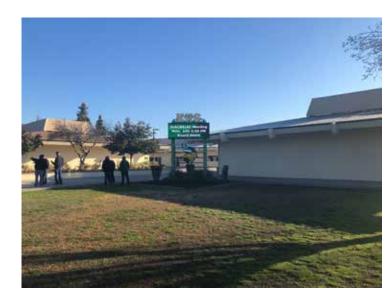
- It was observed that the parent drop-off area is highly congested in the morning, and this congestion causes a potentially dangerous back-up of traffic on 18<sup>th</sup> avenue. Many students cross 18<sup>th</sup> avenue to arrive at school, and the crosswalks are located before the parent drop-off areas, so students are forced to cross the street in-between cars that are idling or waiting to turn into the drop-off area.
- Create drive through loading zone lane in front of Administration bldg
- Relocate electronic marquee closer to front of school/street for better visibility

Create loading zone in front of Admin.

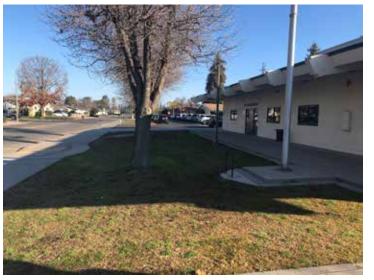
Create loading zone in front of Admin.

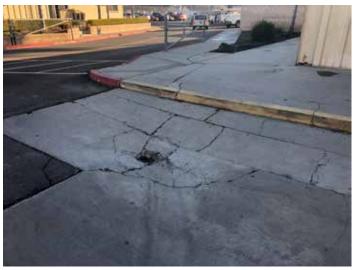
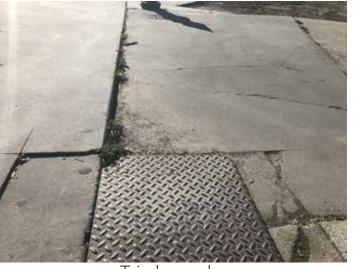
- □ The greatest facility need at Kingsburg High School is obvious when one first walks on campus-hardscape. The concrete walkways and guad areas throughout the campus exhibit numerous stress cracks and chips. In some case, large concrete sections have pulled apart, resulting in a deep fissure that could catch a toe. In addition, the hardscape is undulating in many places, and the grades that were established when the concrete was poured are far steeper than today's regulations, cause gullies, cracks, and dangerous elevation drops. The north side of the Old Gym exhibits some of these problems. Water collects in many places in these gullies. In some case, the drain caps are broken or no longer sit level, probably due to settling of the concrete.

Trip hazards

- **D** Replace site concrete to eliminate damaged areas, uneven grades, trip hazards and non-compliant ADA paths of travel.
- **I** Recommend district give first priority to creating compliant ADA paths of travel between most public areas on campus.

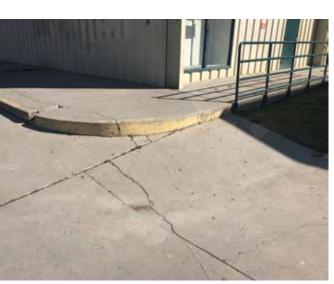
Damaged pavement

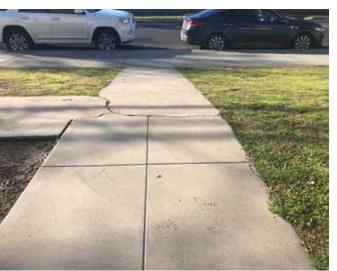
Non-compliant ADA path of travel

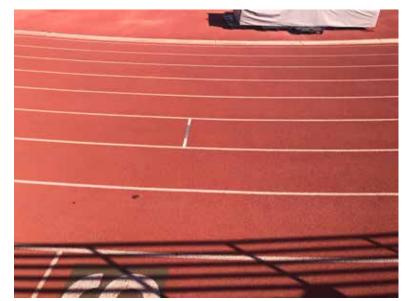
- **Athletic Facilities & Other**
- Pool needs to be replastered
- □ Track needs to be resurfaced
- □ Softball field exterior wheelchair lift has excessive maintenance and compliance costs.
- □ A switchback aluminum ramp may be a cost effective long term solution.
- Gym needs a sidewalk extended around the east side of the building.
- □ Recommend district create a 5-10 year asbestos abatement plan for buildings known to contain asbestos floor files
- □ Important for district to maintain current certified AHERA (Asbestos Hazard Emergency Response Act) report
- □ Replace cloth shade sail structure with hard roof

Resurface track

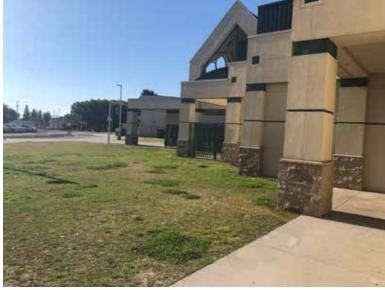
Extend walkway around east side of gym

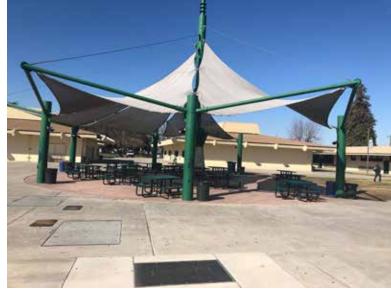
Replace shade structure

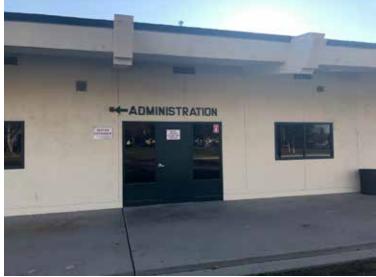
- Glue-lam rafter tails have significant water damage/dry rot (approx. 28 beams)
- □ Architect or structural engineer can investigate if the rafter tails can be trimmed back to eliminate damaged areas
- □ Remaining damaged areas should be treated, sealed and capped with sheet metal to prevent further damage
- □ Replace exterior drinking fountain with ADA-compliant fountains
- □ Encapsulated asbestos floor tiles likely to be disturbed when carpet is replaced requiring abatement

Administration Building

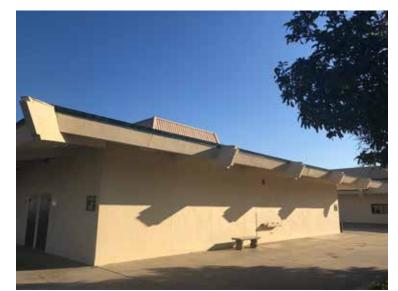
Exterior drinking fountain

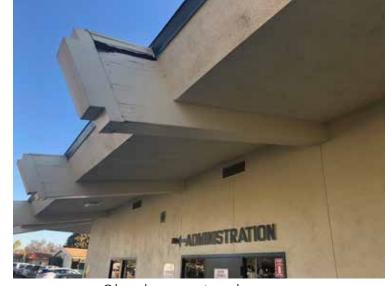
Glue-lam water damage

Administration Bldg	Description of deficiency & recommended action	Area/Units	Construction Cost	Support Costs	Total Cost	Priority Ranking
Roofing Trea	t rot and seal/add metal cap/paint on glue-lam rafter ends	28 ea	\$14,000	\$3,500	\$17,500	3
Flooring/Carpet Rem	ove carpet & hazmat tile- replace with carpet(or polish concrete)	7200 sf	\$115,200	\$28,800	\$144,000	2
ADA Compliance(Bldg) ADA	compliant bi-level drinking fountain	1 ea	\$2,500	\$625	\$3,125	2
Total			\$131,700	\$32,925	\$164,625	
Building 10	Description of deficiency & recommended action	Area/Units	Construction Cost	Support Costs	Total Cost	Priority Ranking
le la	t rot and seal/add metal caps/paint on glue-lam rafter ends ove carpet & hazmat tile - replace with carpet (or polish concrete)	✓ 30 ea 9200 sf	\$15,000 \$147,200	\$3,750 \$36,800	¥18,750 \$184,000	3 2
	h & paint exterior stucco walls to prevent further damage	3600 sf	\$147,200	\$30,800 \$4,500	\$184,000 \$22,500	3

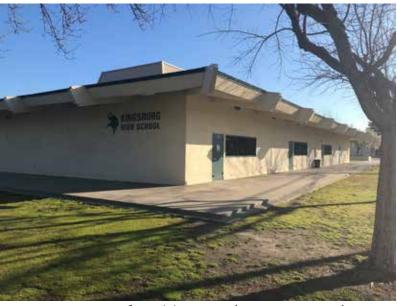
- Glue-lam rafter tails have significant water damage/dry rot (approx. 30 beams)
- □ Architect or structural engineer can investigate if the rafter tails can be trimmed back to eliminate damaged areas
- □ Remaining damaged areas should be treated, sealed and capped with sheet metal to prevent further damage
- □ Patch & paint exterior stucco walls to eliminate large cracks & prevent further damage
- **□** Replace exterior drinking fountain with ADA-compliant fountains
- Encapsulated asbestos floor tiles likely to be disturbed when carpet is replaced requiring abatement.
- □ Modify student restrooms for ADA-compliance

Exterior of Building 10 (rooms 10-15)

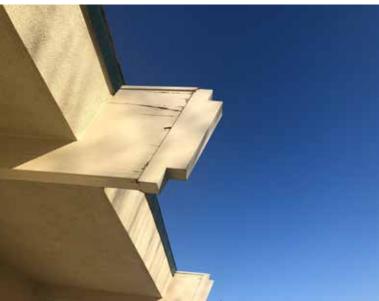
Glue-lam water damage

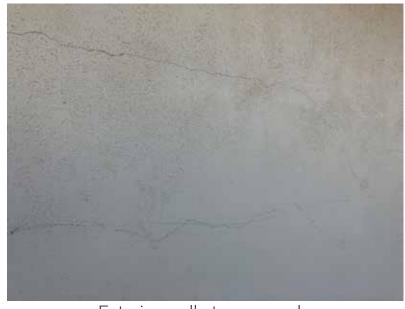
Exterior wall stucco cracks

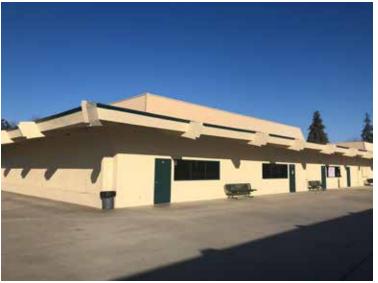
- Glue-lam rafter tails have significant water damage/dry rot (approx. 28 beams)
- □ Architect or structural engineer can investigate if the rafter tails can be trimmed back to eliminate damaged areas
- □ Remaining damaged areas should be treated, sealed and capped with sheet metal to prevent further damage
- □ Patch & paint exterior stucco walls to eliminate large cracks & prevent further damage
- □ Encapsulated asbestos floor tiles likely to be disturbed when carpet is replaced requiring abatement.

Exterior of Building 20

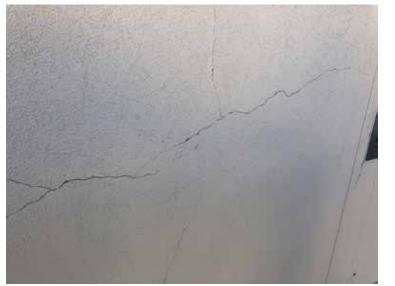
Exterior wall stucco cracks

compliance & cosmetic upgrades	300 sf	\$20,000	\$4,300 \$5,000	\$22,000 \$25,000	2
	compliance a cosmetic upgrades	1 ea	\$2,500 \$2,500	\$625	\$23,000 \$3,125	2
Total		I Ed	\$2,300 \$202,700	\$50,675	\$3,123 \$ <b>253,375</b>	Z
Building 20	Description of deficiency & recommended action	Area/Units	Construction Cost	Support Costs	Total Cost	Priority
Roofing Trea	t rot and seal/add metal caps/paint on glue-lam rafter ends	28 ea	\$14,000	\$3,500	\$17,500	3
Flooring/Carpet Rem	ove carpet & hazmat tile - replace with carpet (or polish concrete)	9200 sf	\$147,200	\$36,800	\$184,000	2
Exterior Finishes Pate	h & paint exterior stucco walls to prevent further damage	3600 sf	\$18,000	\$4,500	\$22,500	3

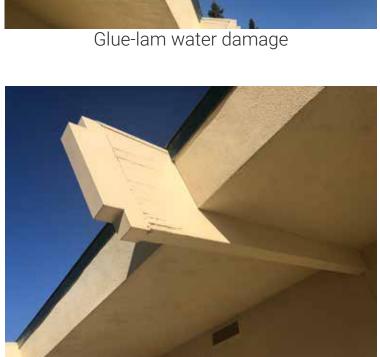
Glue-lam water damage

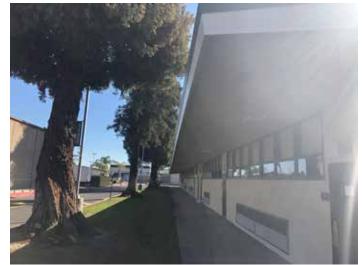
$\hfill\square$  Rock covered roof is damaged and starting to fail

North side of Building 40

- $\hfill\square$  Replace rock roof with comp shingle roof
- $\hfill\square$  Modify student restrooms for ADA-compliance
- There is a small hydrant located just south of room
   48. Due to its short stature and its narrow cap,
   this hydrant may pose a safety hazard. It might
   be advisable to place bollards around this hydrant
   for safety purposes.

Building 40	Description of deficiency & recommended action	Area/Units	Construction Cost	Support Costs	Total Cost	Priority Ranking
Roofing	Remove & replace rock roof	15600 st	\$166,000	\$41,500	\$207,500	3
Restrooms	ADA compliance & cosmetic upgrades	300 sf	\$20,000	\$5,000	\$25,000	2
Total			\$186,000	\$46,500	\$232,500

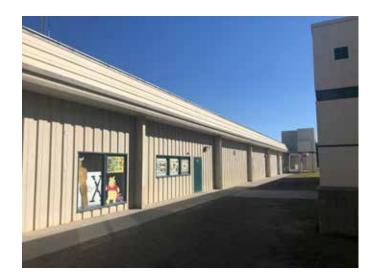
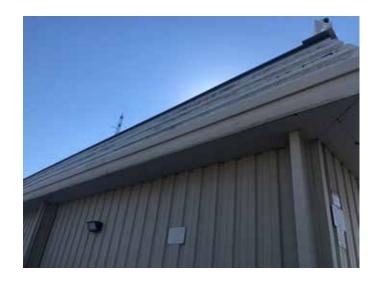
- **□** Replace roof and repair water damage under eaves
- □ District Administration expressed desire to replace this building with a new building

Building 60	Description of deficiency & recommended action	Area/Units	Construction Cost	Support Costs	Total Cost	Priority Ranking
Roofing Remo	ove & replace roof and repair water damage under eaves	9200 sf	\$122,000	\$30,500	\$152,500	3
Total			\$122,000	\$30,500	\$152,500

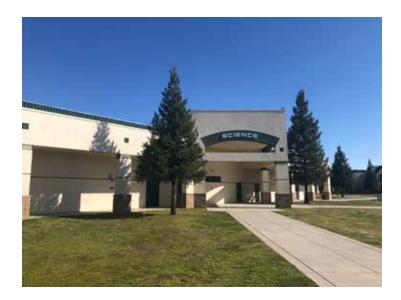
- □ Replace roof
- □ Replace 6 roof-top HVAC units

Building 70	Description of deficiency & recommended action	Area/Units	Construction Cost	Support Costs	Total Cost	Priority Ranking
Roofing	Remove & replace roof	12600 sf	\$126,000	\$31,500	\$157,500	3
Electrical	Upgrade exterior recessed can lighting under eaves	24 units	\$7,200	\$1,800	\$9,000	3
HVAC	Remove & replace HVAC units	6 units	\$45,000	\$11,250	\$56,250	3
Total			\$178,200	\$44,550	\$222,750

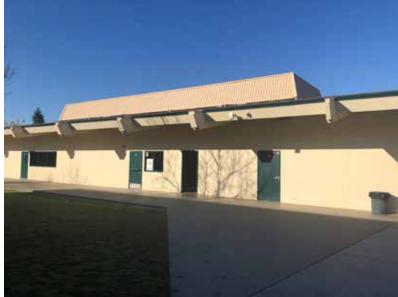
- Glue-lam rafter tails have significant water damage/dry rot (approx. 28 beams)
- □ Architect or structural engineer can investigate if the rafter tails can be trimmed back to eliminate damaged areas
- □ Remaining damaged areas should be treated, sealed and capped with sheet metal to prevent further damage
- □ Encapsulated asbestos floor tiles likely to be disturbed when carpet is replaced requiring abatement.
- □ Modify student restrooms for ADA-compliance

Exterior of Building 80 (rooms 80-87)

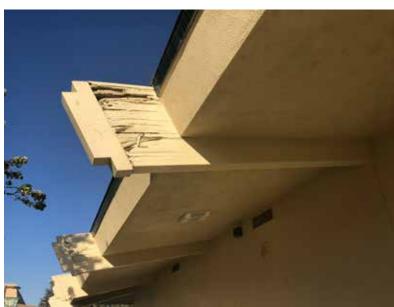
Glue-lam water damage

Building 80	Description of deficiency & recommended action	Area/Units	Construction Cost	Support Costs	Total Cost	Priority Ranking
Roofing	Treat rot and seal/add metal caps/paint on glue-lam rafter ends	28 ea	\$14,000	\$3,500	\$17,500	3
Flooring/Carpet	Remove carpet & hazmat tile - replace with carpet (or polish concrete)	9200 sf	\$147,200	\$36,800	\$184,000	2
Restrooms	ADA compliance & cosmetic upgrades	300 sf	\$20,000	\$5,000	\$25,000	2
Total			\$181,200	\$45,300	\$226,500	
						Ĩ
Library	Description of deficiency & recommended action	Area/Units	Construction Cost	Support Costs	Total Cost	Priority Ranking
Electrical	Upgrade exterior recessed can lighting under eaves	20 units	\$6,000	\$1,500	\$7,500	3
	Remove & replace HVAC units (1 of the units as soon as possible)	5 units	\$37,500	\$9,375	\$46,875	2
Total			\$43,500	\$10,875	\$54,375	
Board Room	Description of deficiency & recommended action	Area/Units	Construction Cost	Support Costs	Total Cost	Priority Ranking

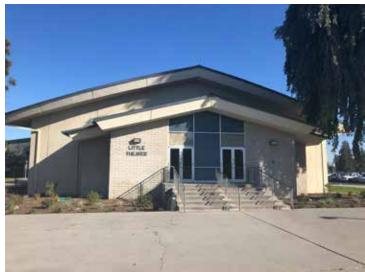
- □ Install sump pumps to stop ADA-access ramps from flooding
- □ Replace front lawn with concrete to create outdoor gathering/reception space
- □ Chiller system is unreliable and requires excessive maintenance, upgrade to HVAC package units

Exterior of Little Theater Building

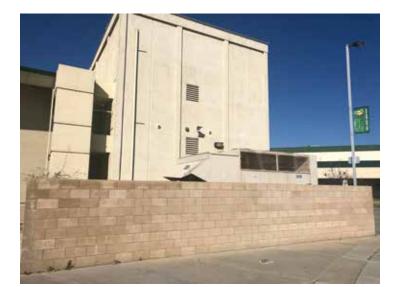
Chiller system

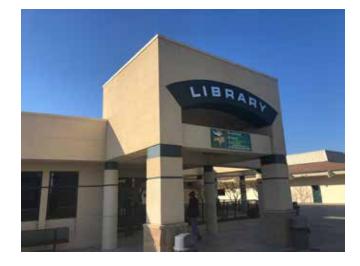
□ Replace roof-top HVAC units (5 total, 1 reported bad and needs immediate replacement.)
